THE  
QUEBEC LAND SLIDE  
OF 1889.

C. BAILLAIRGE, M. CAN. SOC. C. E.

**THE QUEBEC LAND SLIDE OF SEPTEMBER 19, 1889.**

By CHAS. BAILLAIRGÉ, M. Can. Soc. C. E.

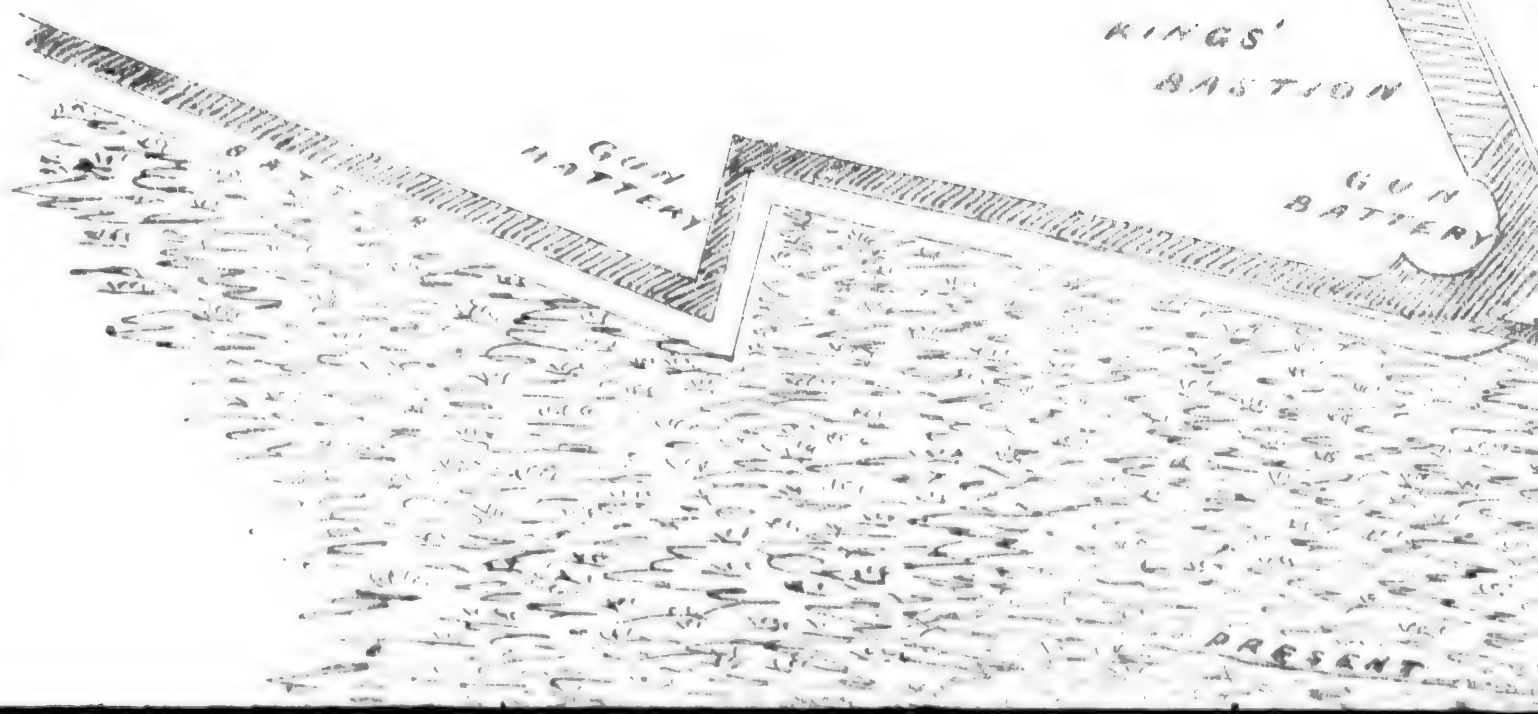
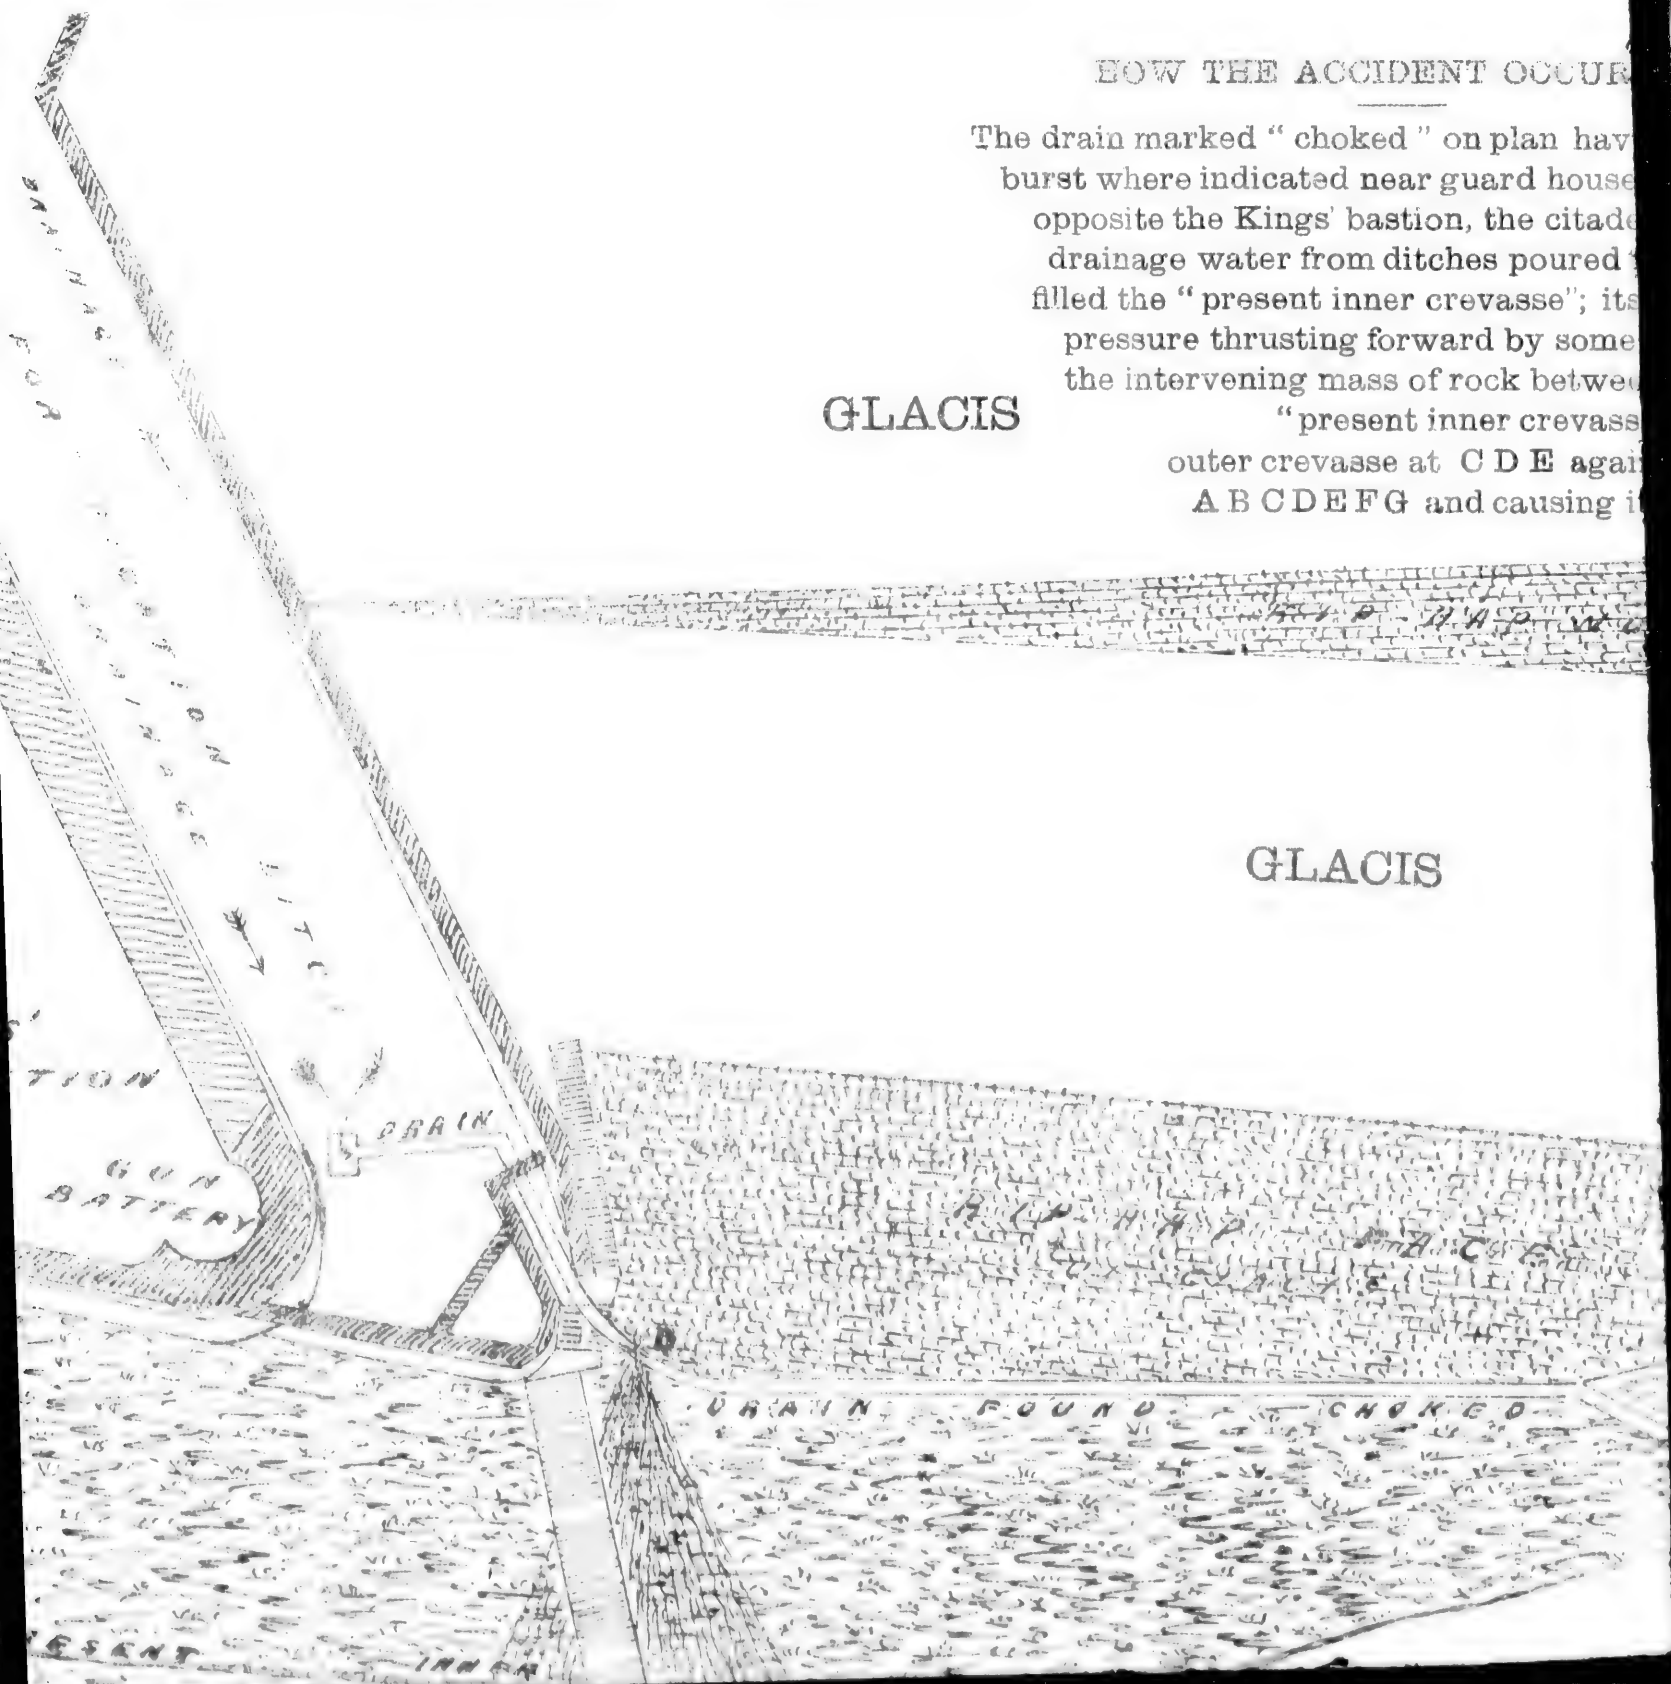
## HOW THE ACCIDENT OCCURRED

The drain marked "choked" on plan have burst where indicated near guard house opposite the Kings' bastion, the citadel drainage water from ditches poured filled the "present inner crevasse"; its pressure thrusting forward by some the intervening mass of rock between "present inner crevasse" outer crevasse at C D E again A B C D E F G and causing it

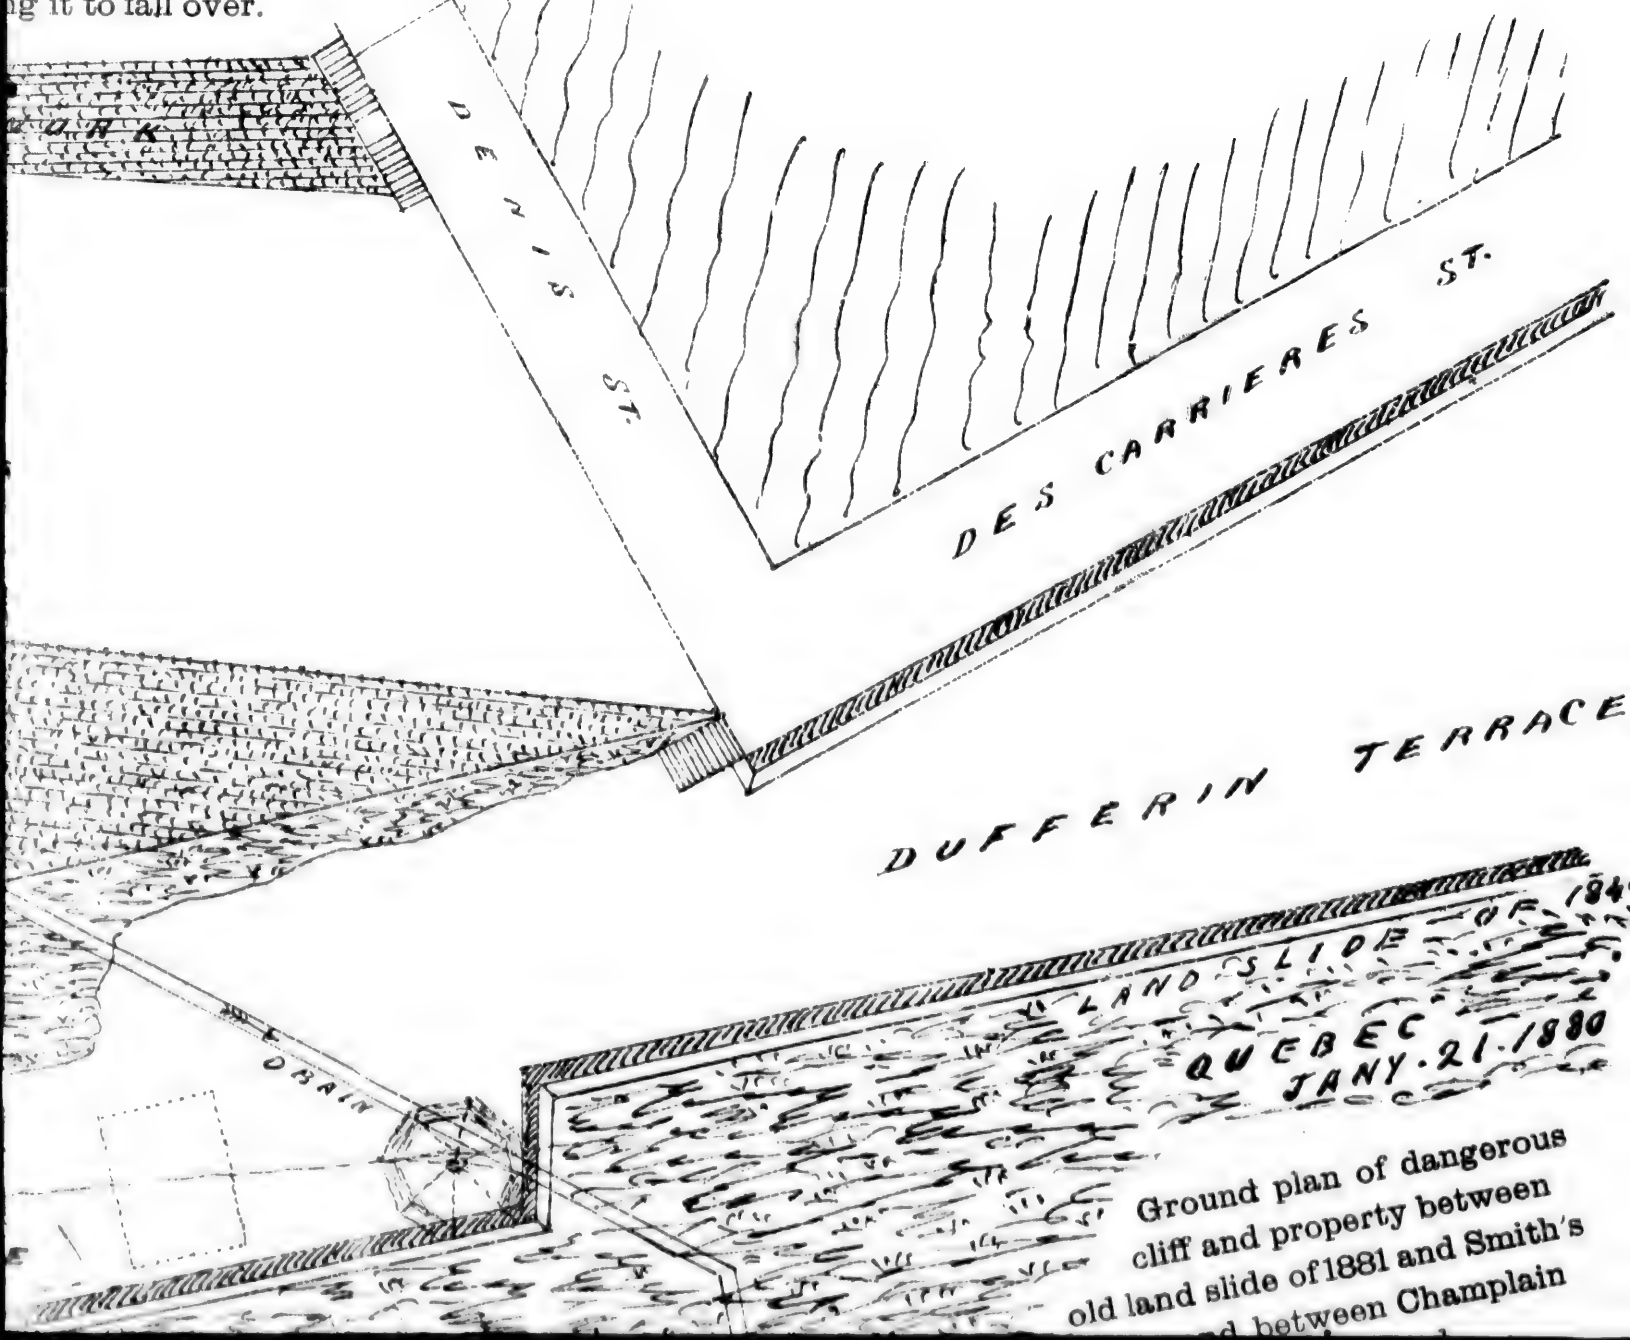
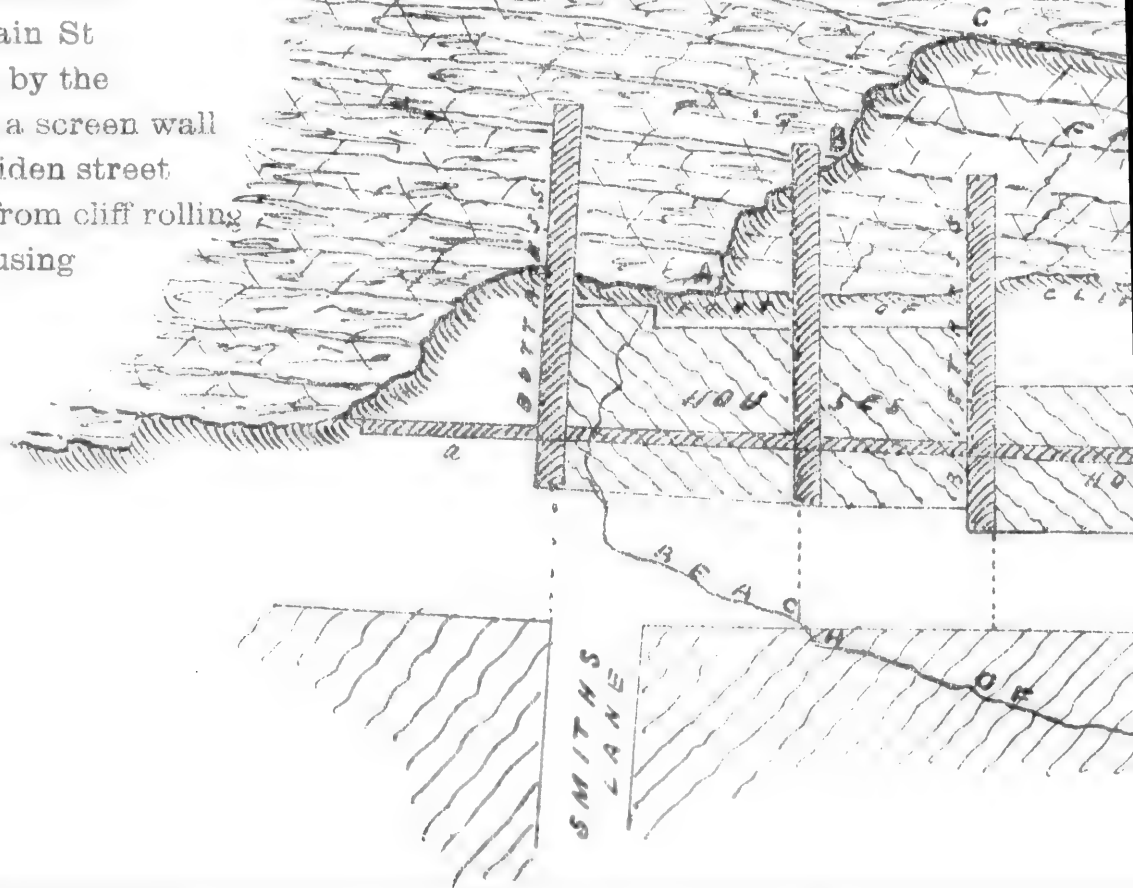
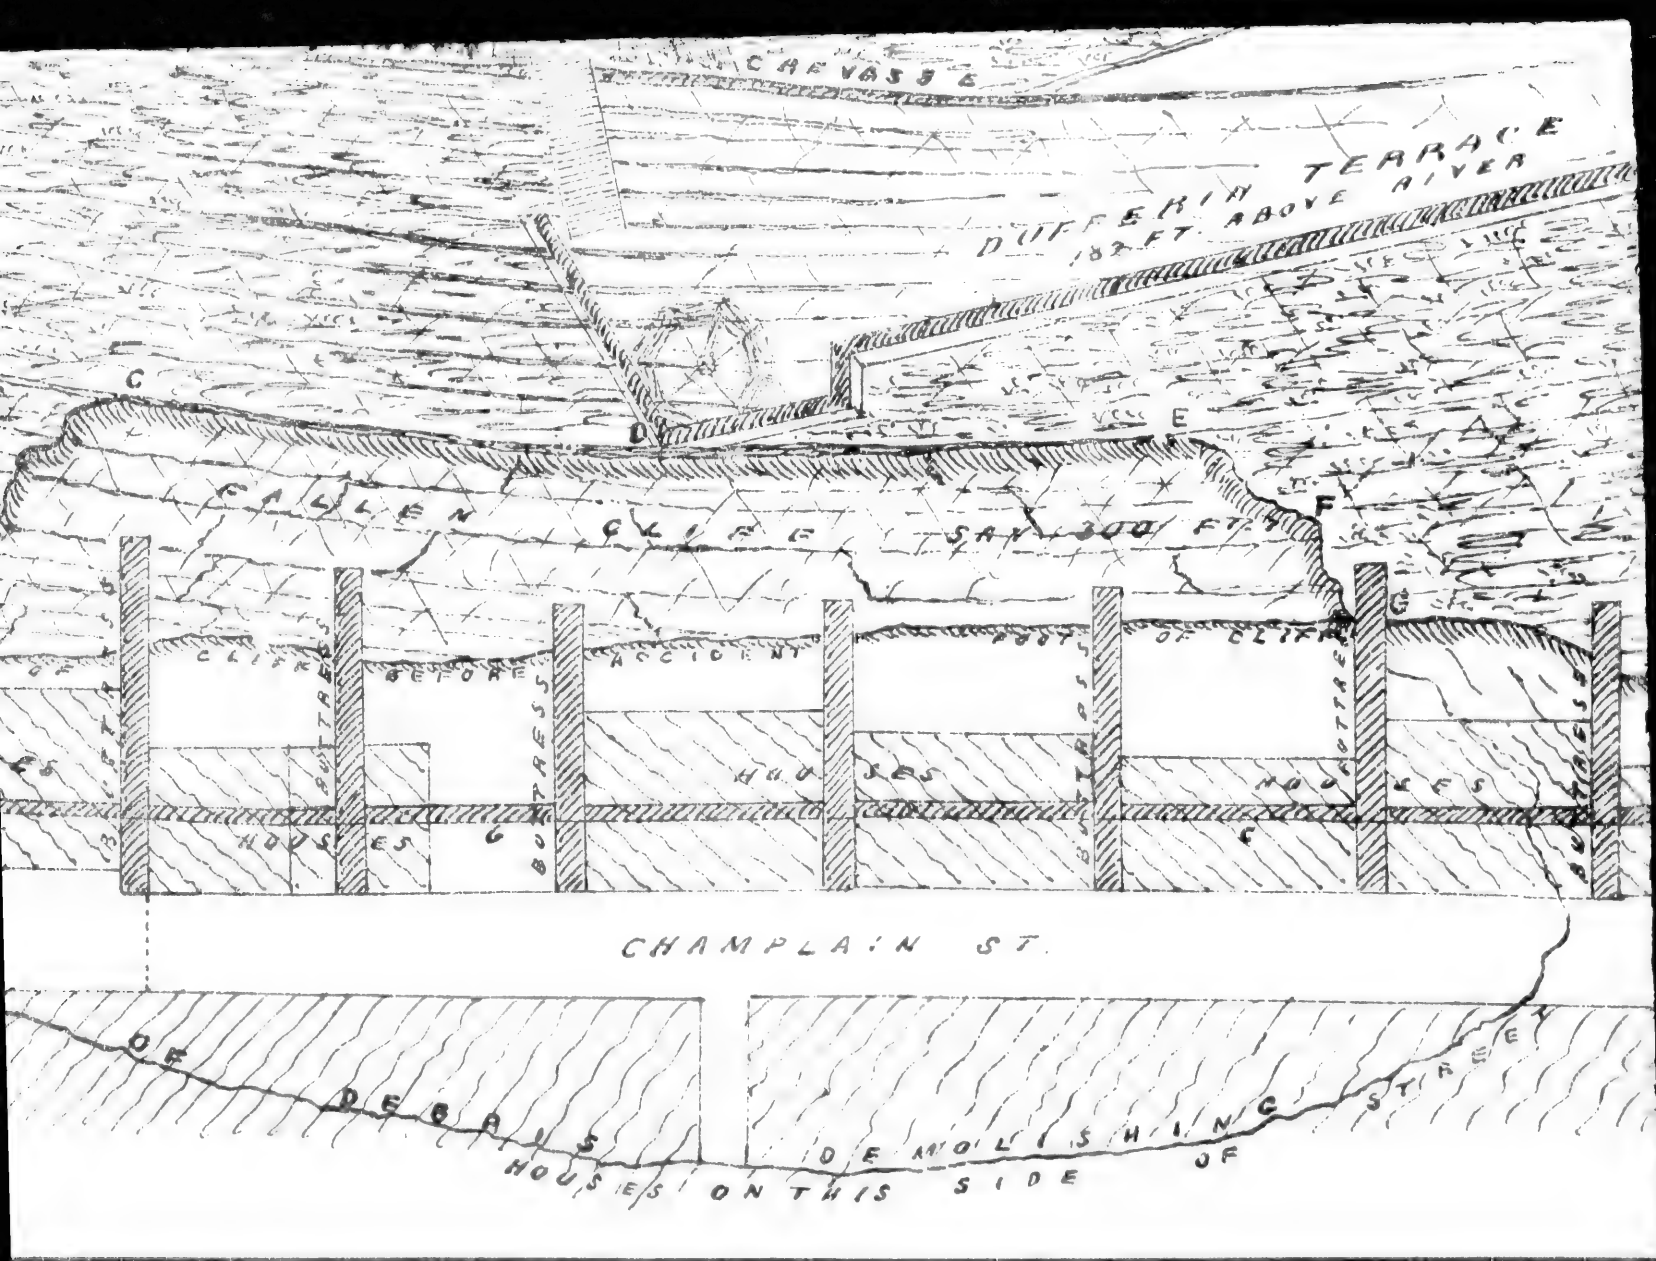
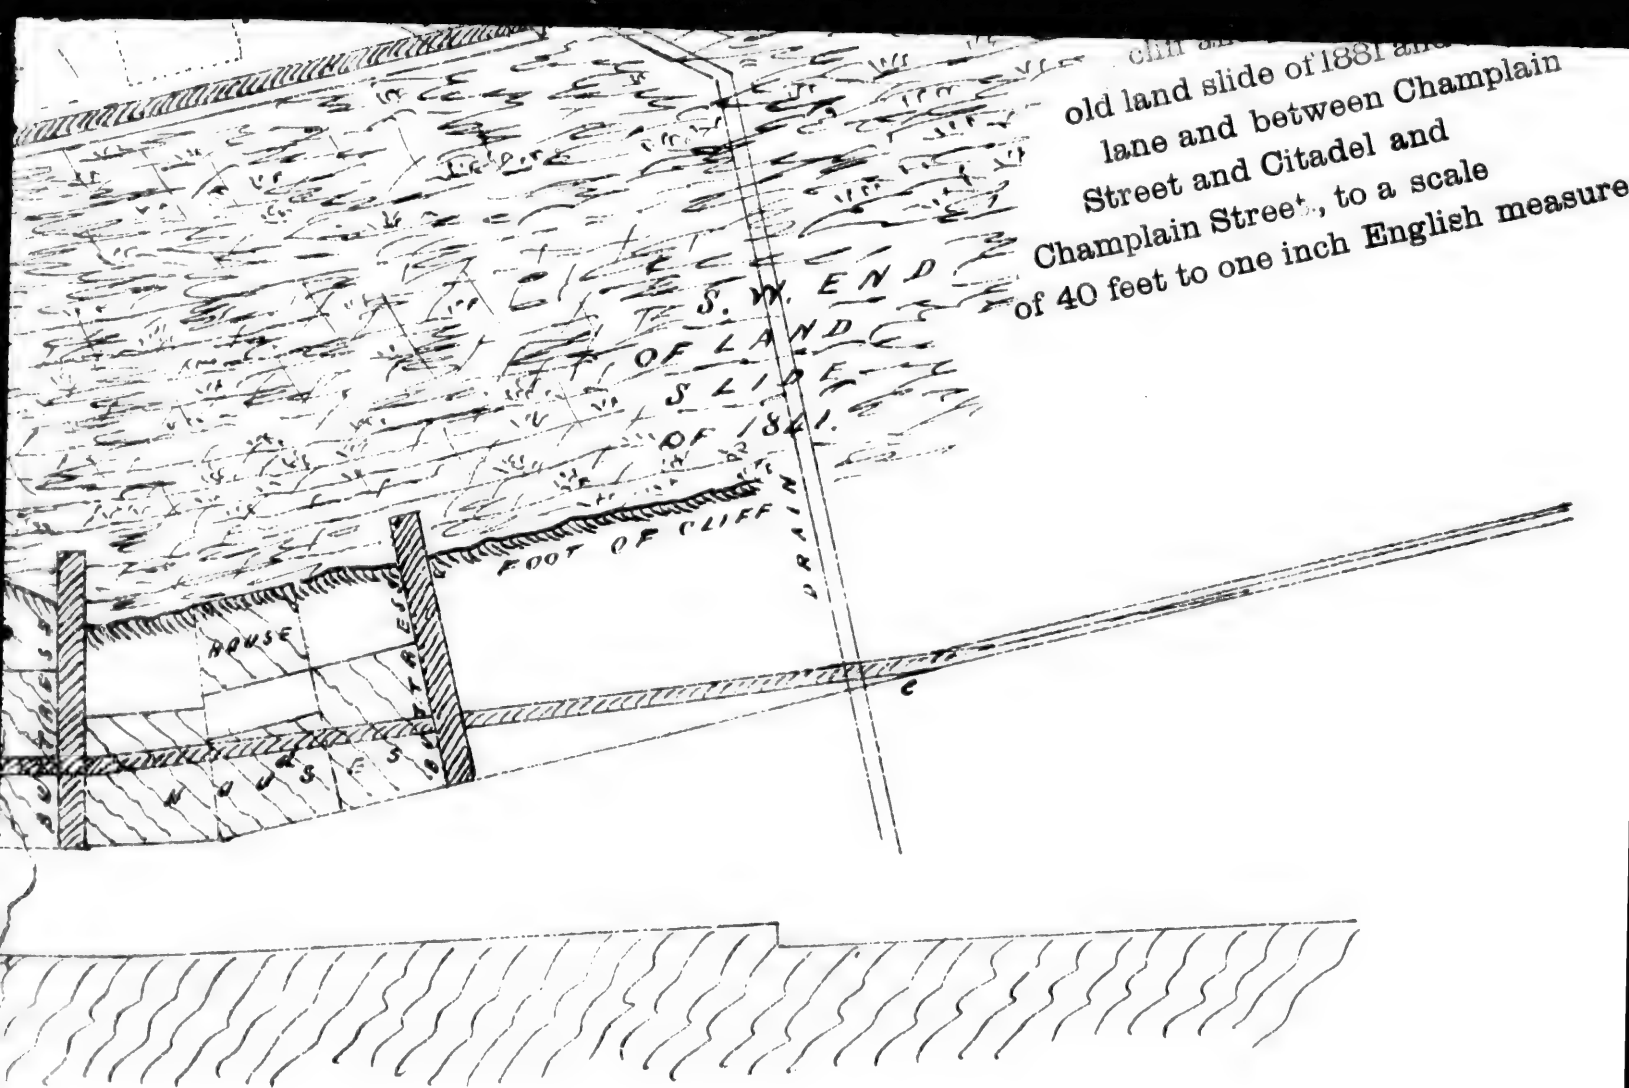
Plate IV is a plan or bird's-eye view of a portion of the Citadel and Glacis, the south-western extremity of Dufferin Terrace, and that part of Champlain street overtaken by the avalanche, or which was likely to be in case of an eventuality.

N. B. The "houses" so indicated along west side of Champlain St were after 1880 purchased by the Fed. Govt. demolished and a screen wall built along a b c d e to widen street and guard against stones from cliff rolling over roadway and thus causing accidents.

old land slide of 1881 and  
lane and between Champlain  
Street and Citadel and  
Champlain Street, to a scale  
of 40 feet to one inch English measure

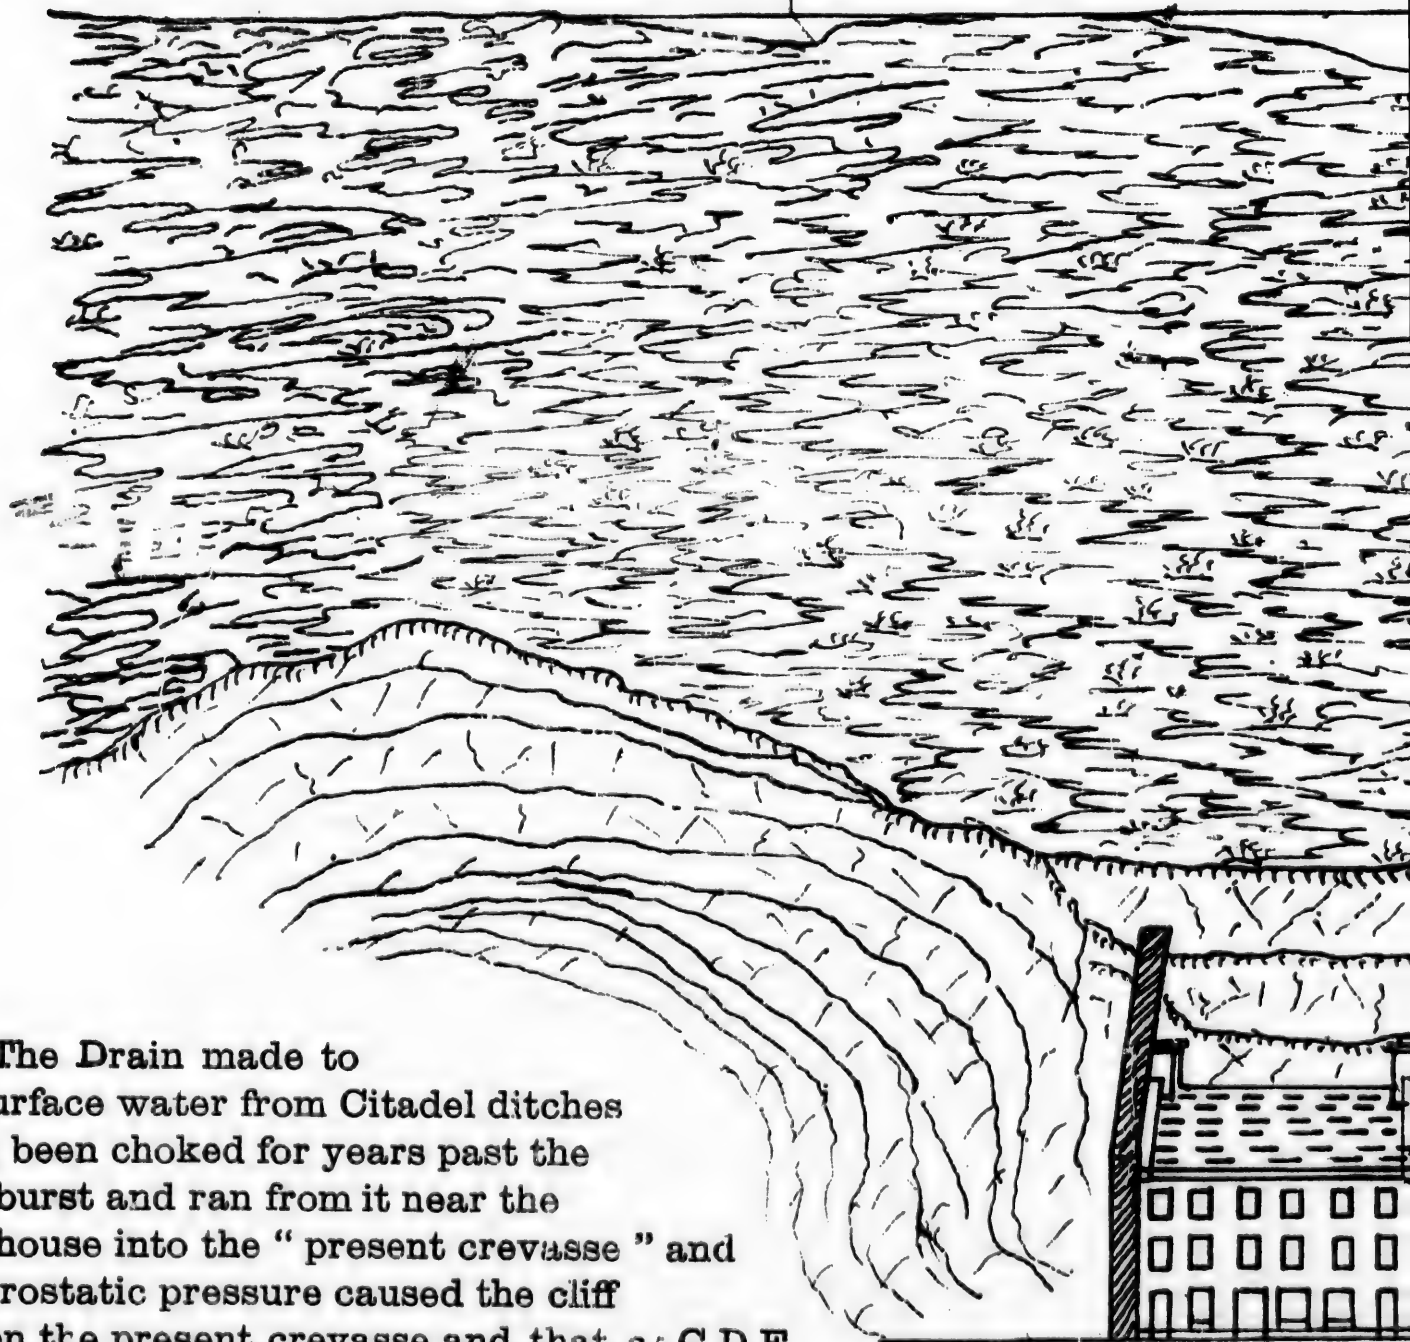
N. B. The Drain made to take surface water from Citadel ditches having been choked for years past the water burst and ran from it near the guard house into the "present crevasse" and by hydrostatic pressure caused the cliff between the present crevasse and that at C D E to move forward some 6 inches at D which pushed forward the rock beyond D and caused it to fall over.

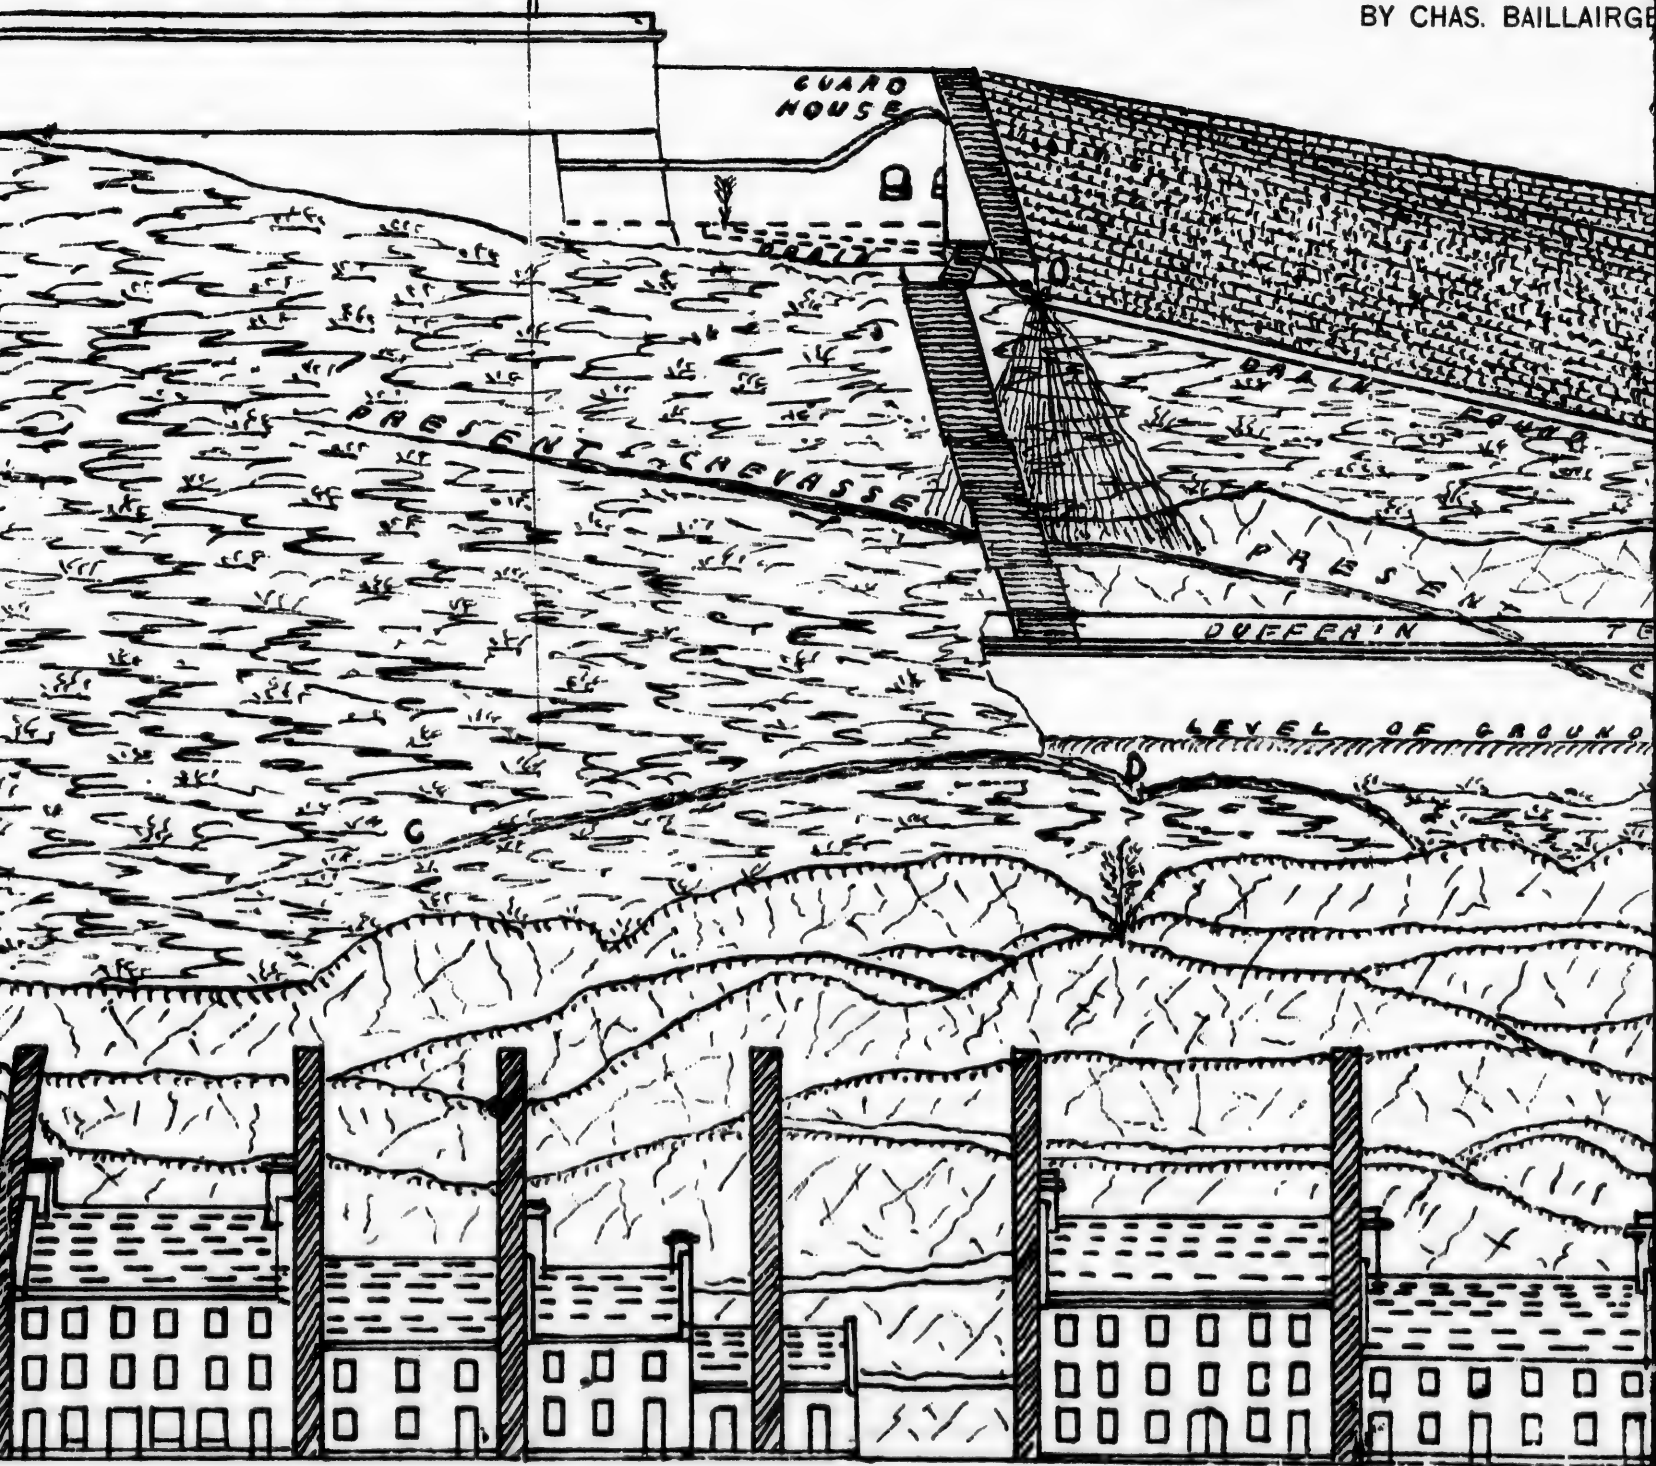
Plate V is an elevation or front view of the cliff, etc., showing the outcrops of the almost vertical strata of the face of the cliff, as shown in Plate VI.

Elevation or front view of dangerous cliff  
along Champlain Street from old land  
slide of 1841 to Smith's lane or to the  
U. S. S. Co's. office, a distance of say 675  
ft. Scale 40ft. to one inch English measure

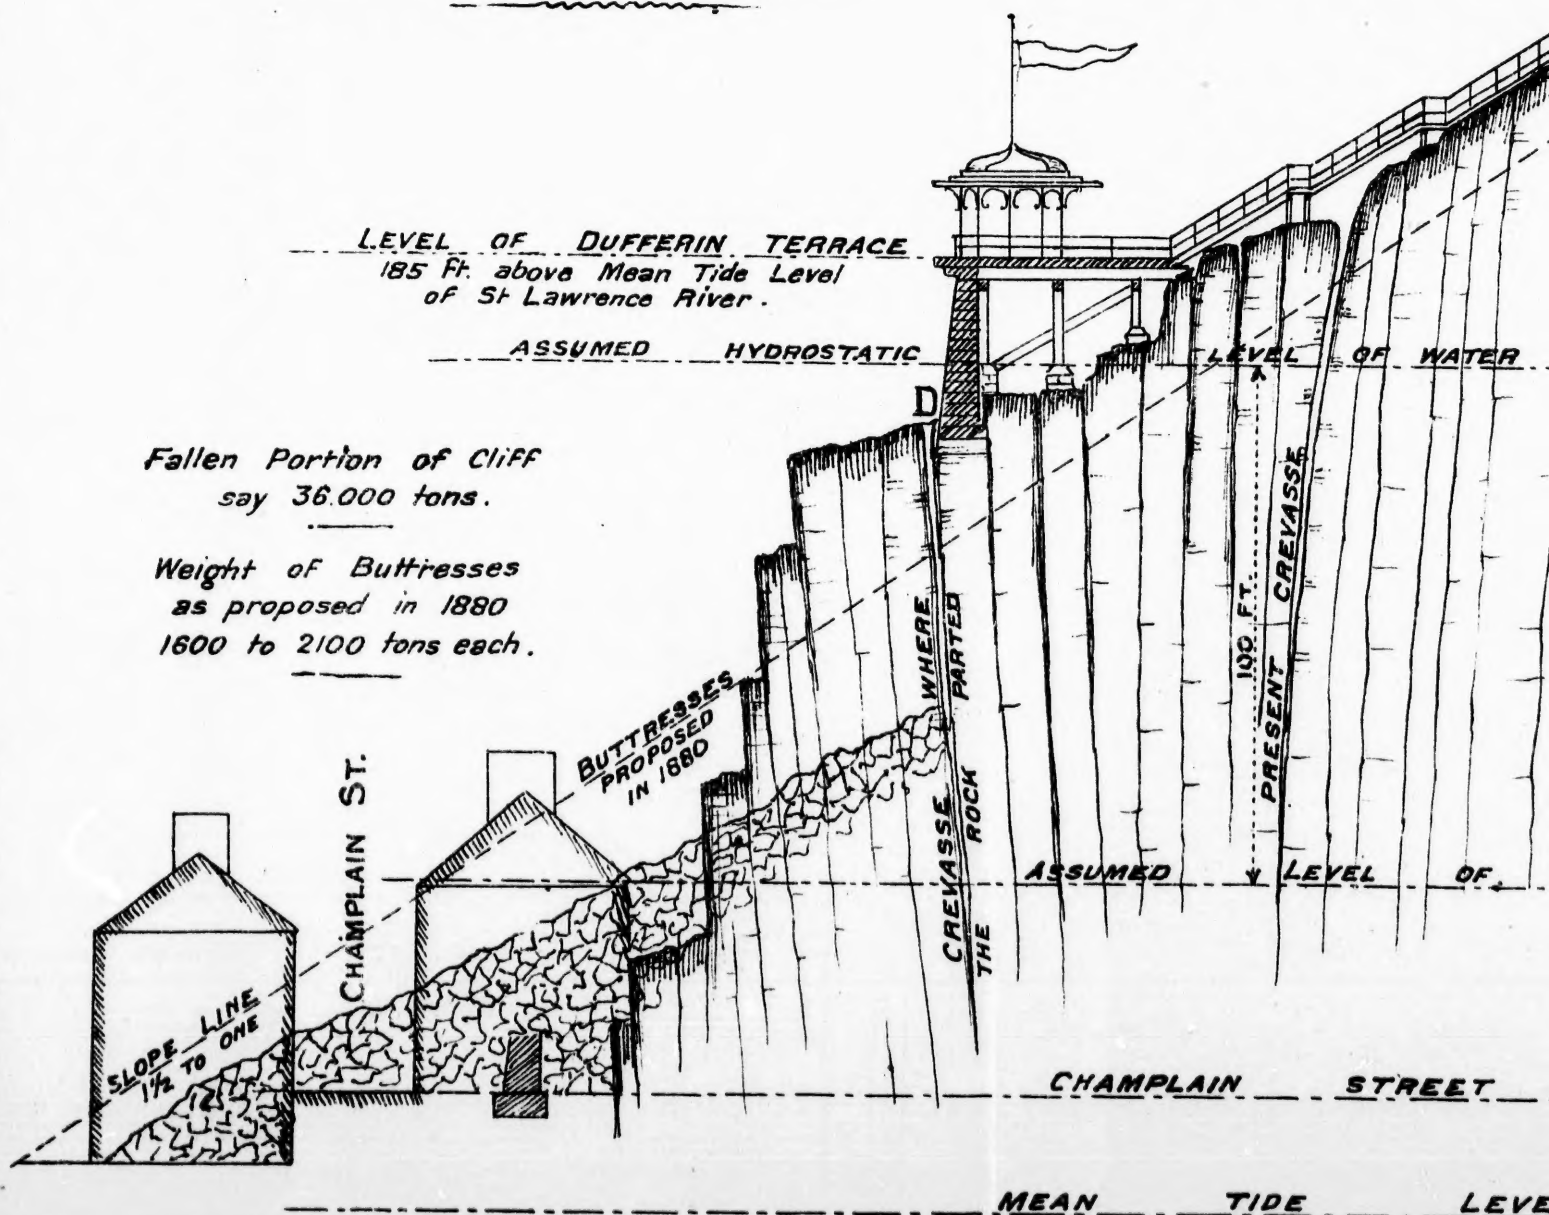
· VERTICAL · SECTION · THROUGH · D ·

Referring now to the following conclusions as to how the slide occurred, it will be understood that *C D E* is the line of outer crevasse along which the cliff parted, *A B C D E F G* that portion of the cliff which was forced out and fell over, the debris reaching, as shown on plan and section, to about 40 feet on the river side of Champlain street.

The crevasse indicated on plan and elevation as "present crevasse" is the one now existing, into which the water poured from the broken drain at *D*, filled the crevasse as hereinafter described, forced out the rock between the two fissures, and caused the portion beyond *C D E* to fall forward.

Intermediary fissures, not at first shown on plan, or not then known to exist, are now sketched in and shown on section, giving the strata their present fan-like, diverging or radiating appearance, and accounting for the fact, that while the present inner and main crevasse is almost

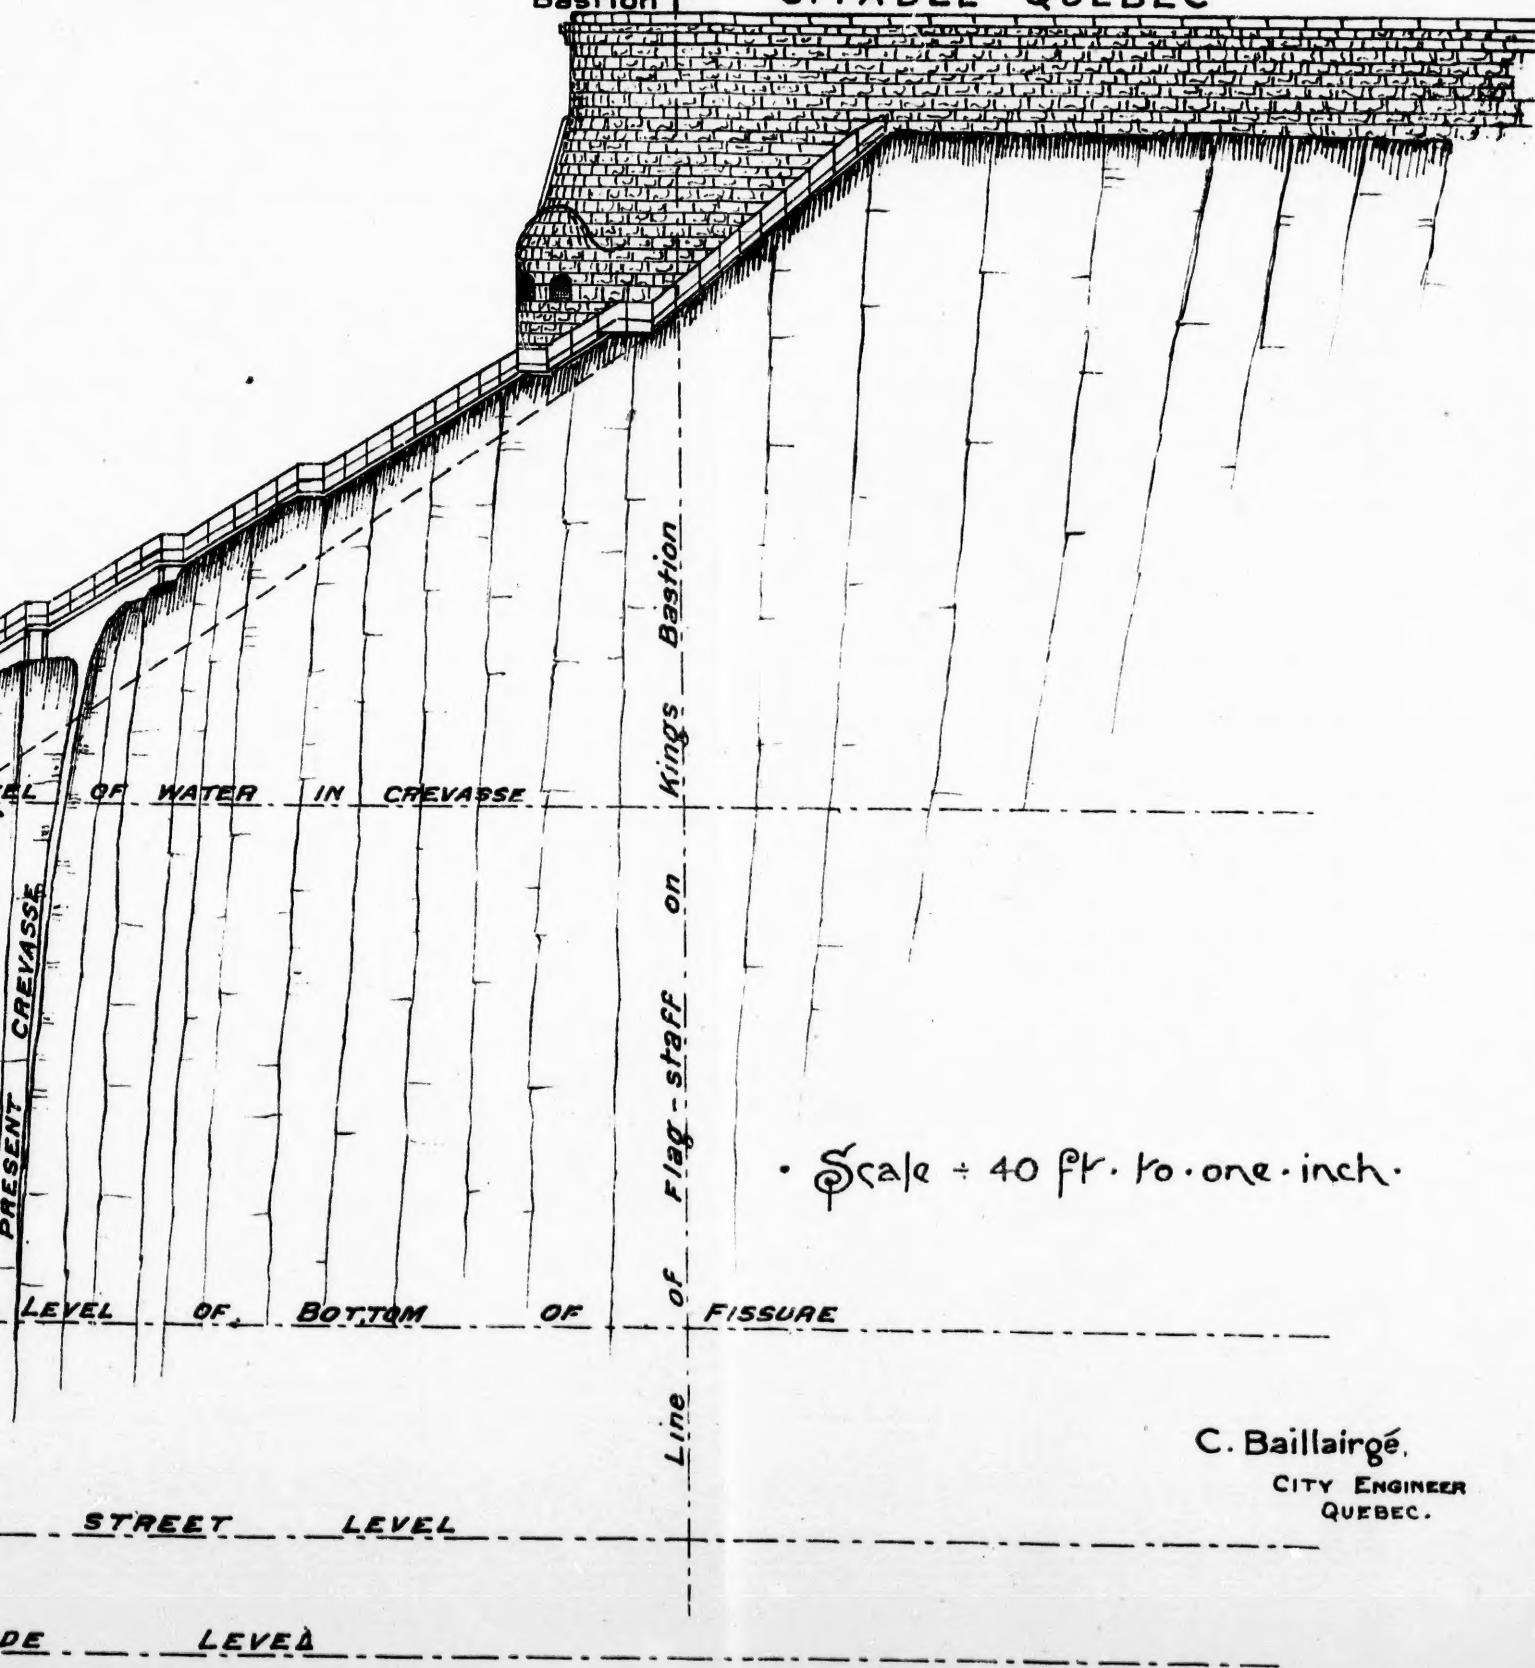
is the present crevasse or fissure into which the water poured and has been pouring for maybe 30 years past, or ever since the drain, which ran north-eastward down the cliff towards the river, ceased to be operative, as evidenced by the author from the fact that from its outcrop half way down the cliff no water had been running for fully that number of years.

HYDROSTATIC LEVEL OF WATER  
IN CREVASSE 'A'
